K&N Mass Air Flow Testing Findings

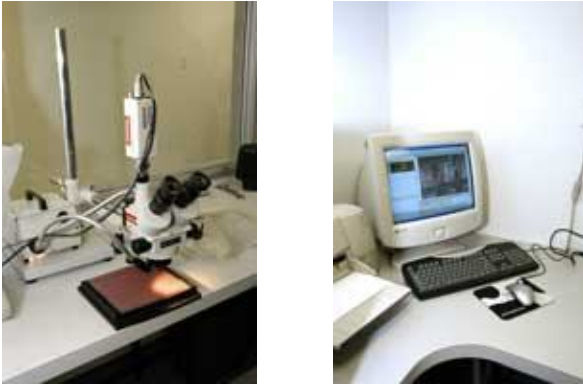
When K&N obtains a MAF sensor in question, our laboratory technicians:

- Inspect it under a microscope to screen for contamination that may be present
- Electrically test for MAF sensor failure by confirming output calibration readings.
- Perform chemical analysis of sensors to determine the source of the contamination where any is present.
- Audit chemical analysis through work with an independent laboratory.
- Interact directly with the dealership involved to supplement with additional facts.

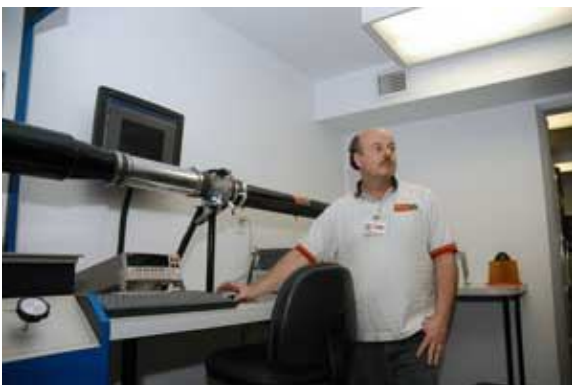
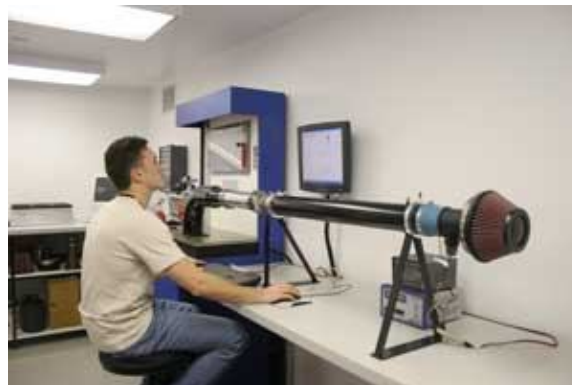
1. K&N's laboratory technicians tested an over-oiled K&N air filter at a rate of 1,000 Cubic Feet per Minute (CFM) on our Filtration Test Stand which utilizes an absolute filter. An absolute filter is one specified by ISO 5011 (SAE testing protocol) which is used to capture test dust that passes through a filter during efficiency testing. In this case, an absolute filter was used to capture any filter oil leaving the filter and to allow us to measure any oil migration from the filter. We weighed the absolute filter before and after the test and confirmed that oil does not migrate from a K&N air filter – even at CFMs far in excess of those seen in production engines.

2. We coated both hot wire and film style sensors with K&N filter oil in both controlled (laboratory) and uncontrolled (real world) environments - none triggered check engine lights. We created extreme conditions, beyond anything an engine would ever experience such as submersing a MAF sensor in filter oil and monitored the sensor readings while spraying it with test dust. Even under these circumstances, the MAF sensor was not damaged. In addition, we were able to take this same MAF sensor, clean it, and found that the readings were identical to the ones taken prior to the extreme testing.
